ET-120 Retrofit Status

ET-120 in Mod Center

Retrofit Work on ET-120 Is Well Under Way

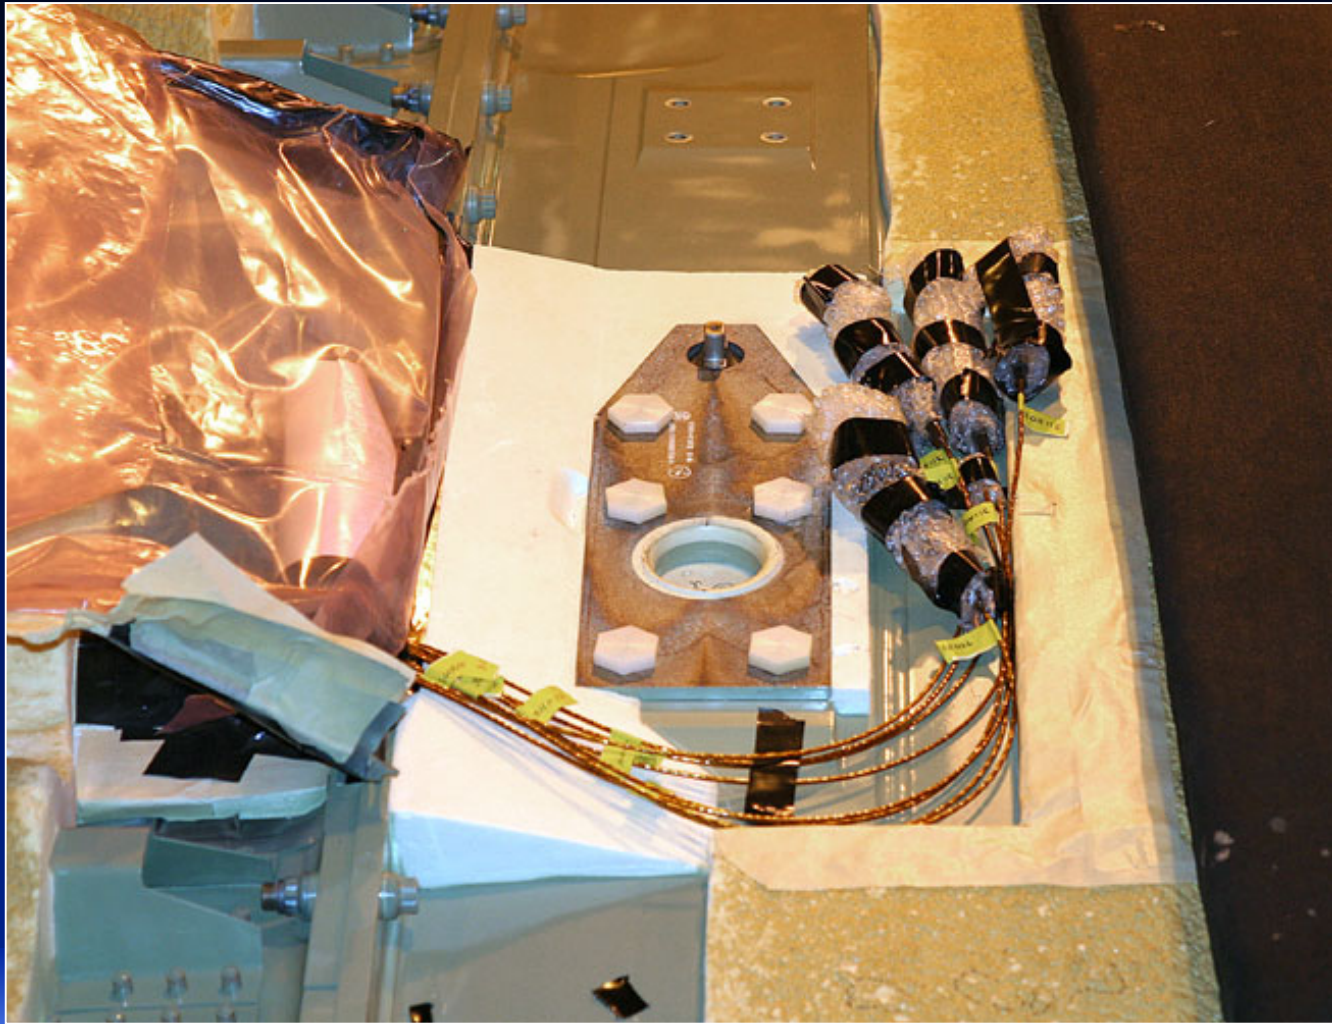
Bipod Redesign

Wedge is Sprayed - Mechanical Installations In-Work

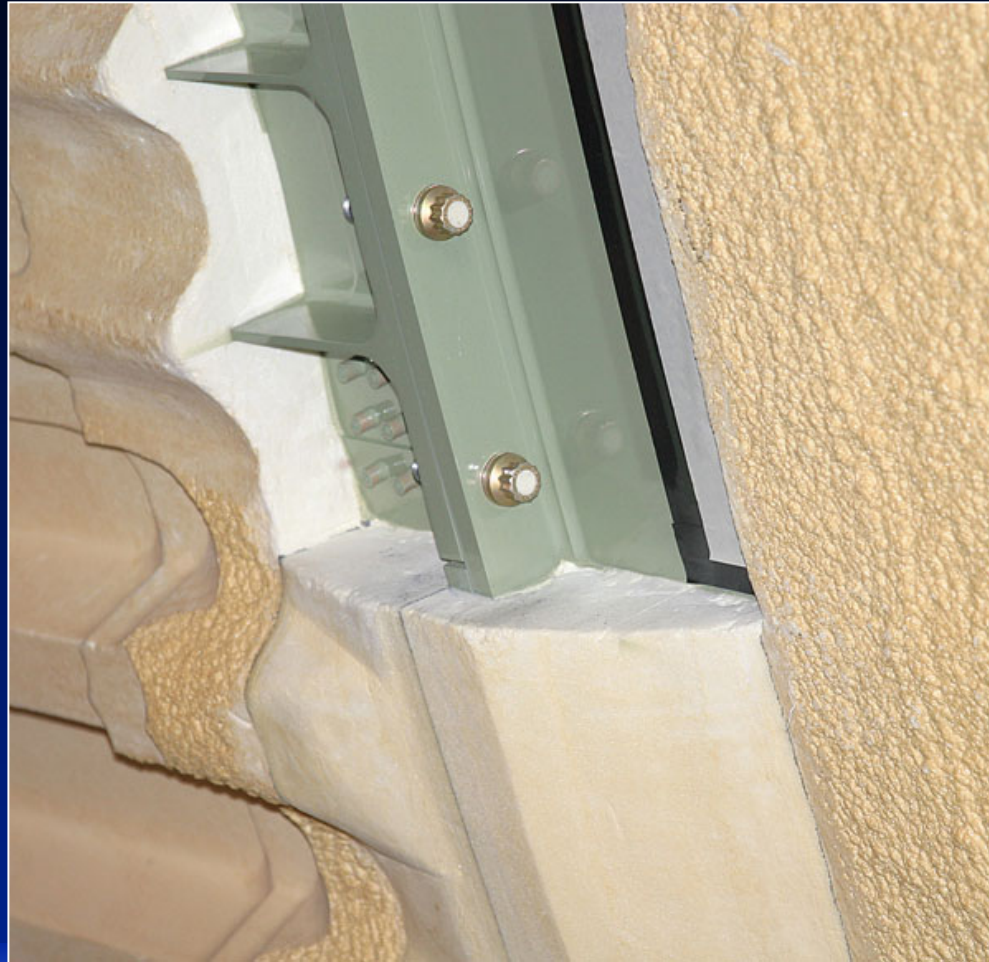
LH2 Flange

Bolts Are Reversed - TPS Closeouts in Validation Process

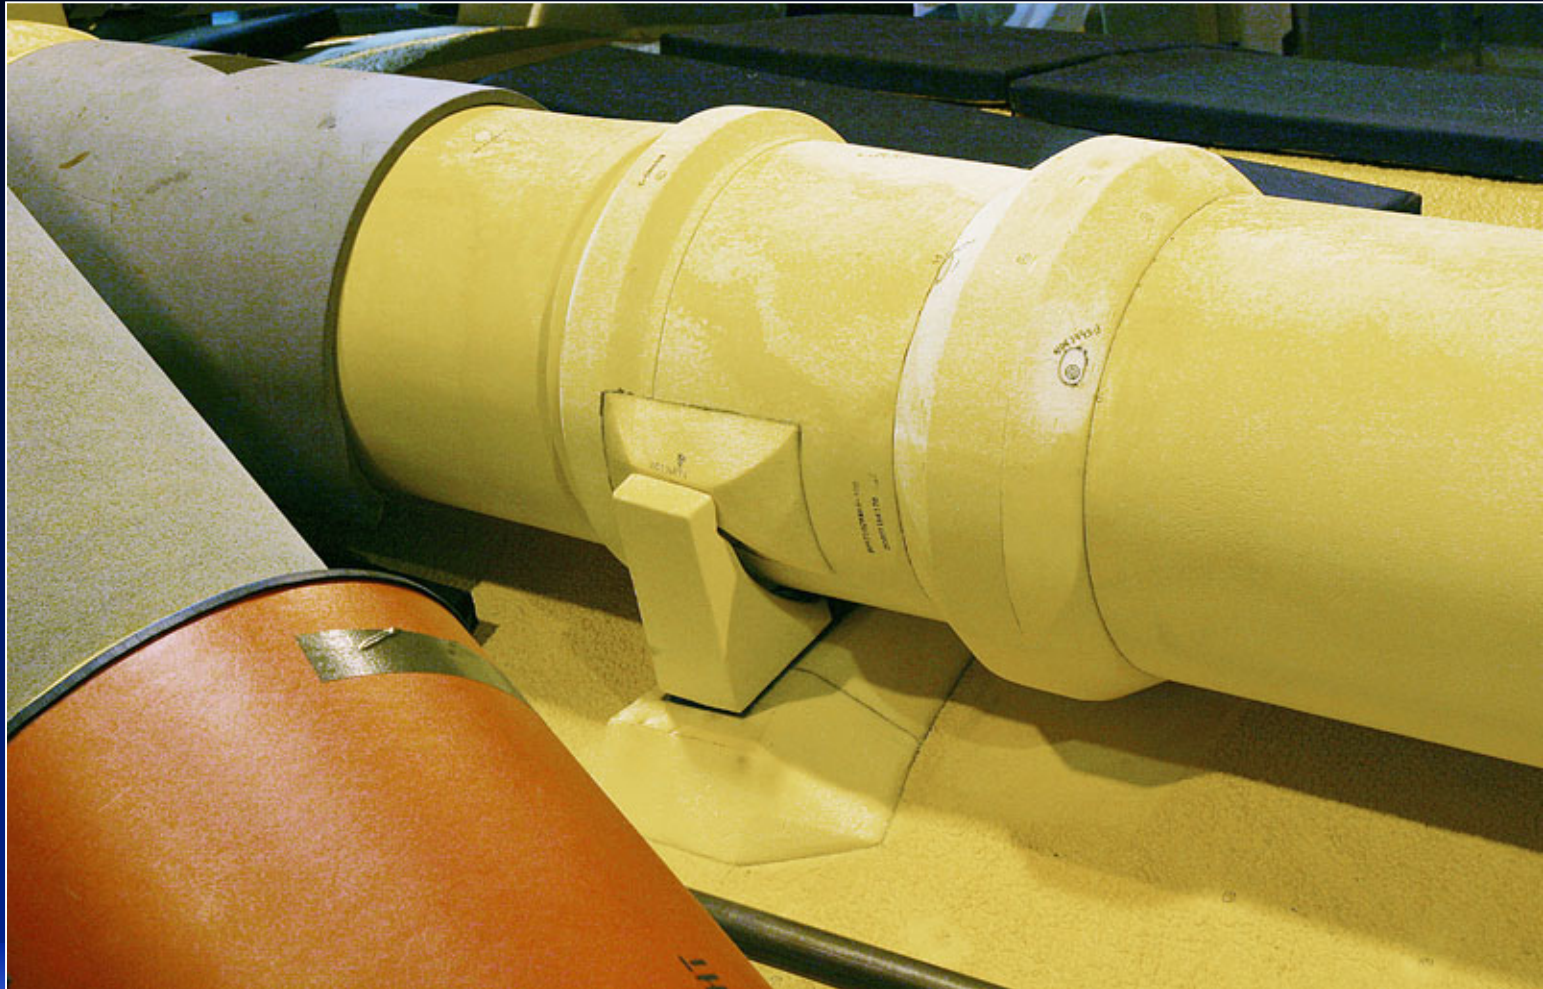
LO2 Feedline Bellows

***Closeout Spray Validated - Pour Closeout
in Validation Process***

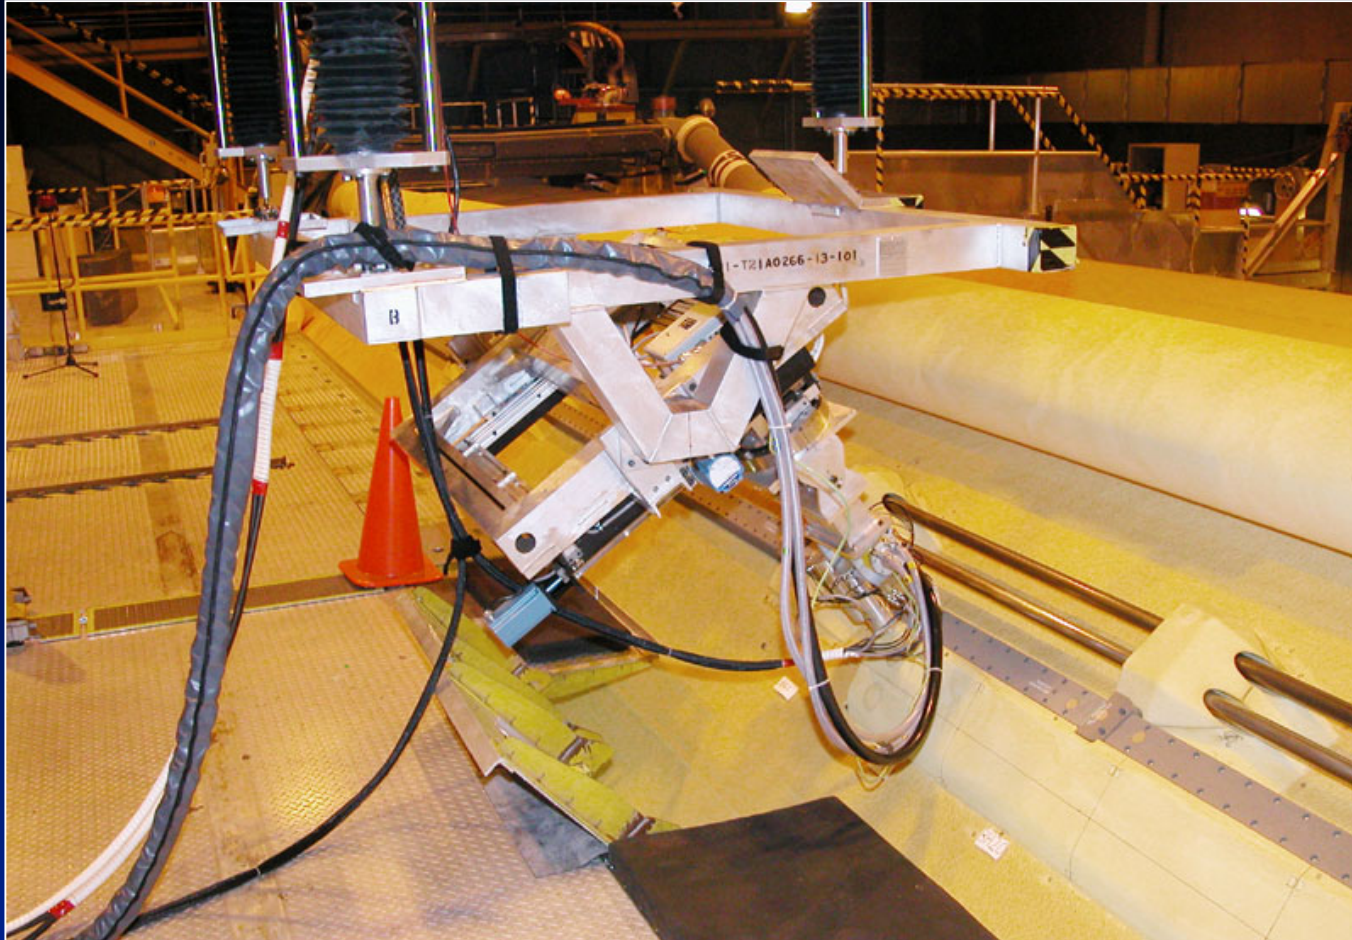
Non-Destructive Evaluation (NDE)

Initial LH2 and LO2 NDE Activities Complete

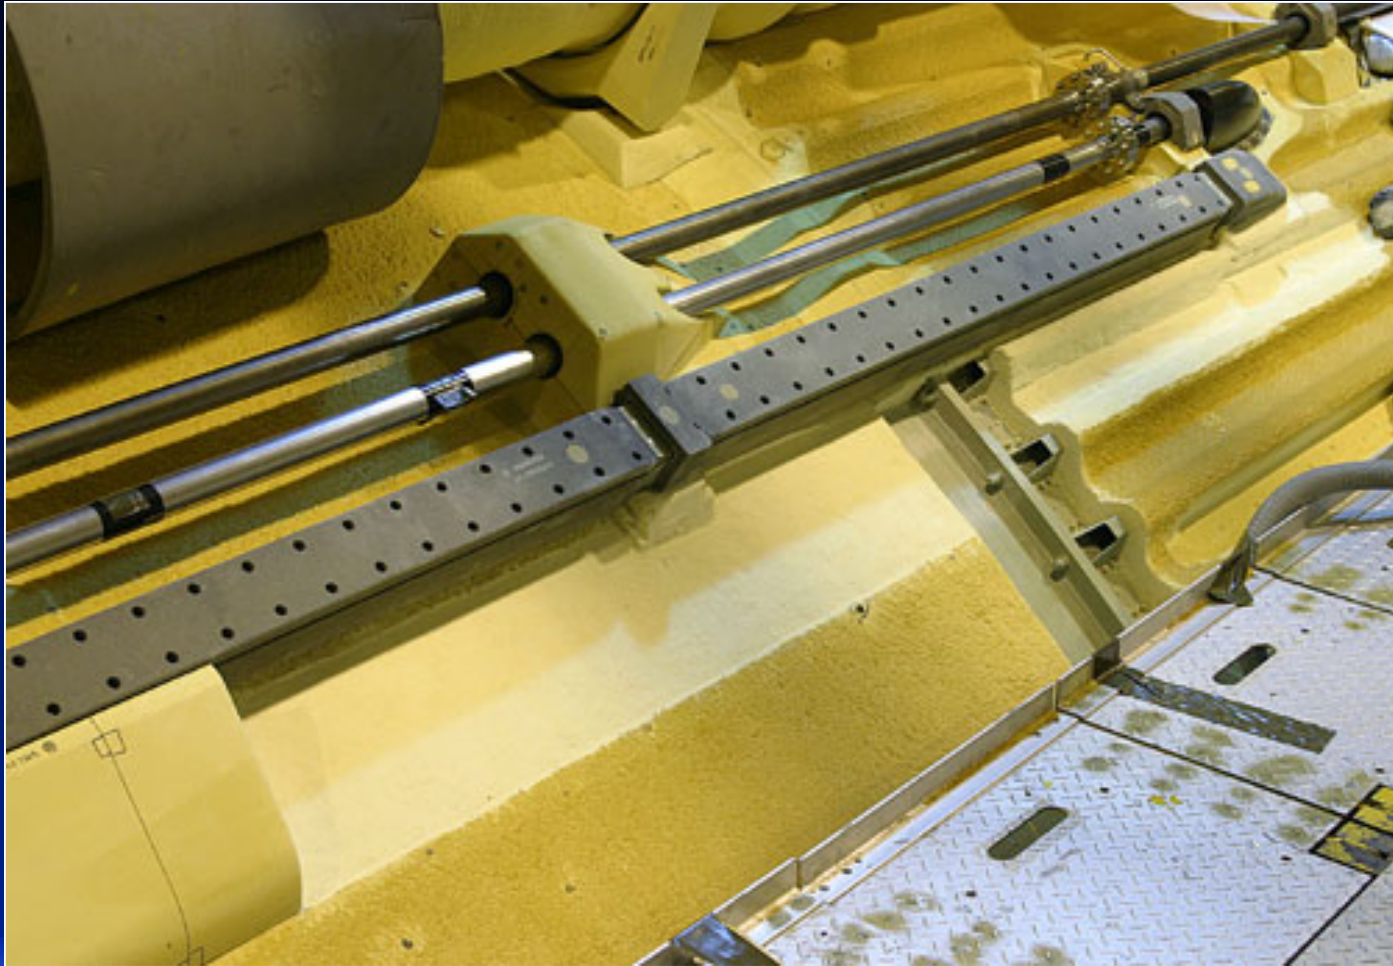
PAL Ramps

***Forward 10 Feet of LH2 Ramp Removed -
Closeout Spray in Validation Process***

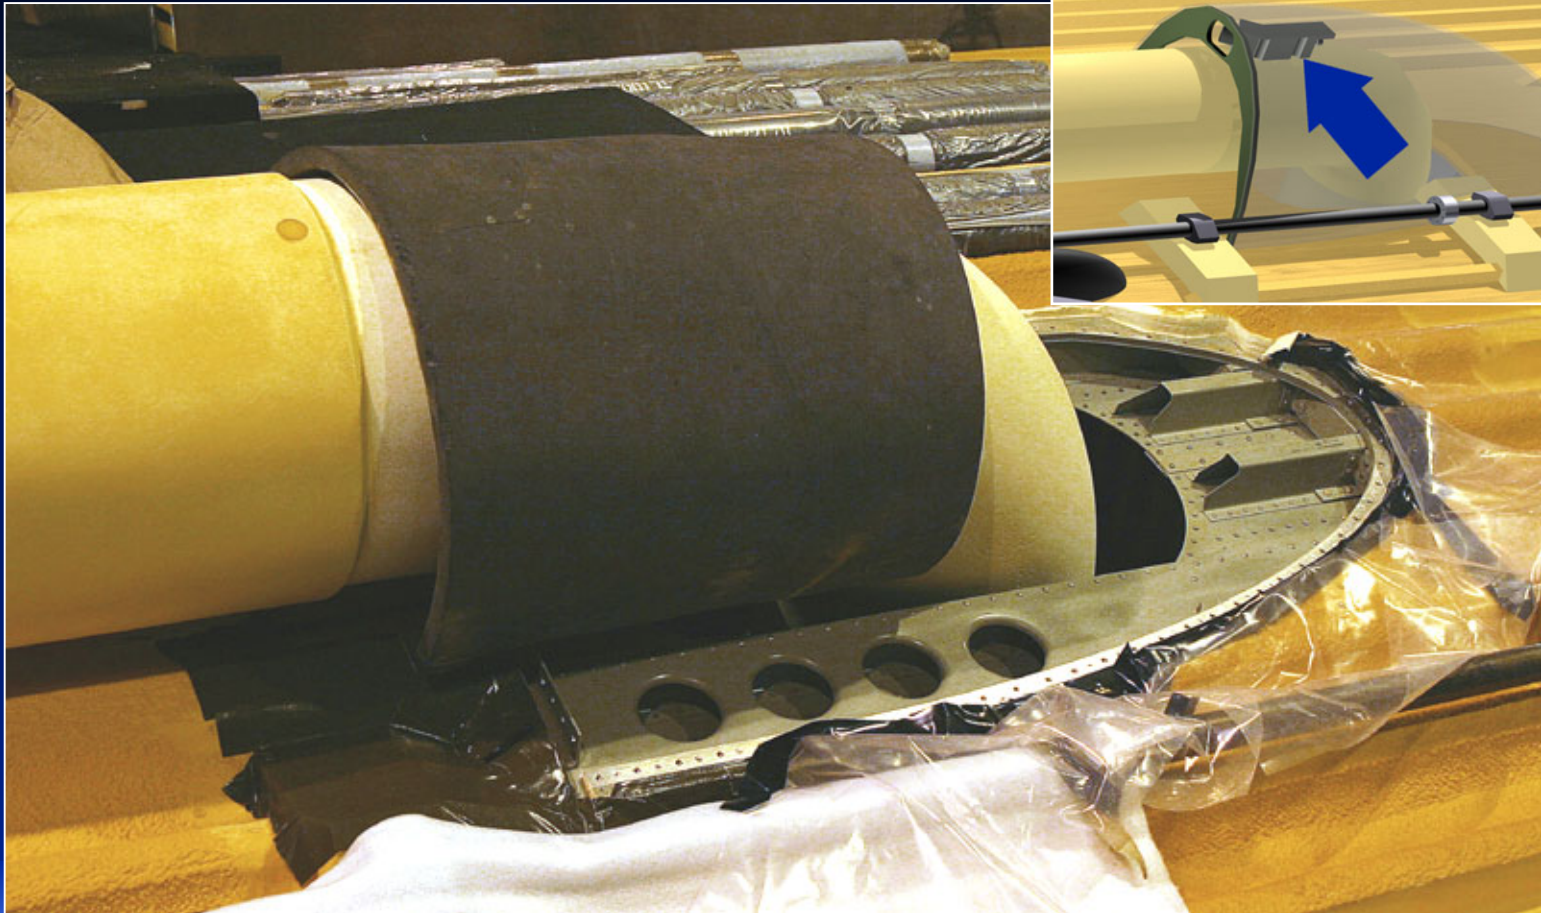
In-Flight Imagery

Harness Installation In-Work
